Coal Combustion Waste Impoundment

Round 7 - Dam Assessment Report

Walter Scott Junior Energy Center

MidAmerican Energy
Council Bluffs, Iowa

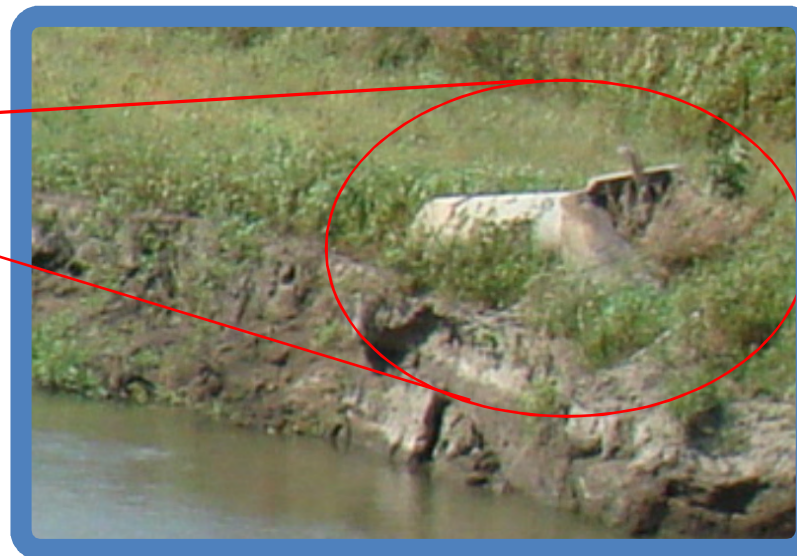
A slough observed on the outside slope of the dike embankment (levee) on the north side of the South Ash Pond does not immediately threaten the safety of the ash pond, but it should be repaired as soon as conditions permit; it is understood that the USACE has plans to do so. Otherwise, the visible parts of the dike embankments were observed to have no signs of overstress, significant recent settlement, shear failure, or other signs of instability, although visual observations of the embankment slopes in some areas were hampered by the presence of a tall growth of sunflowers and weeds.

Photo O.3
Pony Creek levee outside slope South Pond (N side viewed W)

Two field observations relate to repair issues. One concerns the slough on the outside slope of the dike on the north side of the South Ash Pond. Although MidAmerican does not have responsibility for repairing the slough, it is recommended that MidAmerican continue to closely monitor the slough for any worsening conditions, particularly during and after rainstorms, and have a contingency plan for taking quick action, on its own if necessary, should conditions rapidly deteriorate at the slough. Apprise the USACE of any deterioration at the slough.
